# **ENVIRONMENTAL MANAGEMENT PLAN (EMP) REPORT**

## **HBM NIGERIA PLC DEPOT, ONITSHA**

**ONITSHA-ENUGU EXPRESSWAY, OGIDI, IDEMILI NORTH LOCAL GOVERNMENT ANAMBRA STATE**

**HBM NIGERIA PLC**

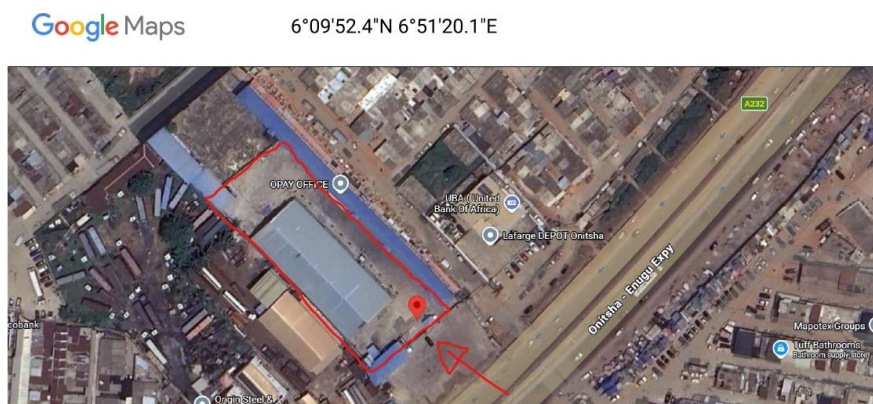
Figure 2.1: Satellite View Showing the Depot Boundary and Immediate Neighbours

The depot lies at Ogidi, in Idemili North Local Government Area of Anambra State, fronting directly onto the Onitsha-Enugu Expressway close to its junction with Nkwelle-Obeledu Road. On satellite imagery the depot's boundary, outlined in Figure 2.1 below, sits at approximately 6°09'52.4"N, 6°51'20.1"E, which corresponds to the Google Plus Code 5V74+R7M, Onitsha. This is consistent with the wider locality coordinate of 6°09'53.6"N, 6°51'17.8"E used to orient the site in Chapter One.

The topography of the site itself is flat, and the compound is fully paved in concrete or compacted material, with no area of bare exposed ground. The depot's compound has no natural infiltration surface left to absorb rainfall, which is precisely why a properly built catchment pit, rather than reliance on the surrounding soil, is the right fix for the waterlogging problem described later in this report. The general area, being part of the Anambra lowlands close to the Niger trough, is not unusual in this respect; what matters more for this EMP is that the depot's own compound has no natural infiltration surface left to absorb rainfall, which is precisely why a properly built catchment pit, rather than reliance on the surrounding soil, is the right fix for the waterlogging problem described later in this report.

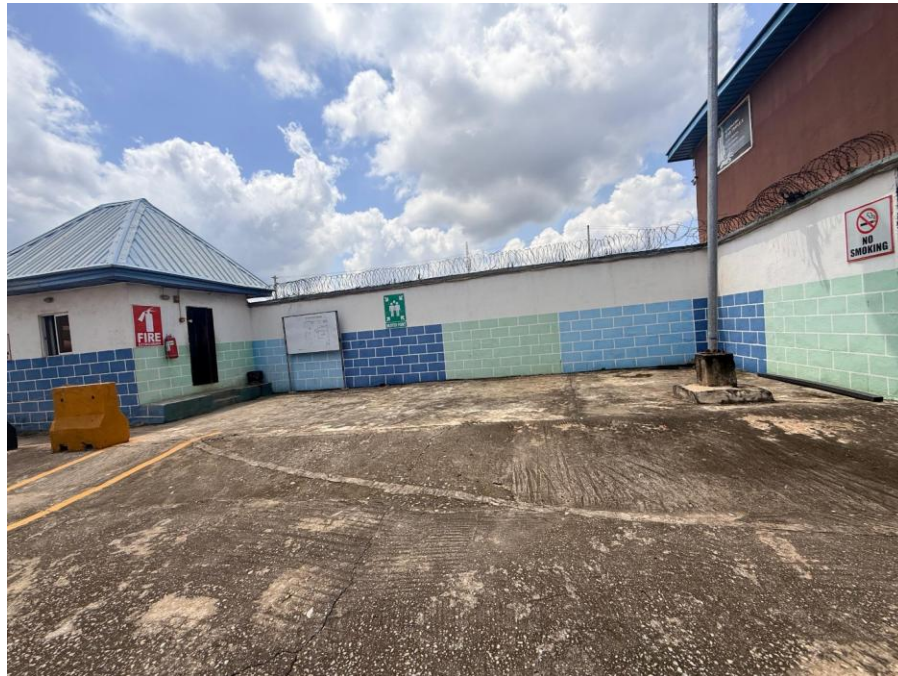
The compound is enclosed on all sides, with the perimeter wall topped with razor wire and a single gated, manned entrance facing the expressway. No-smoking signage is displayed at more than one point in the yard, and a marked muster point sits close to the fire point near the gate. This arrangement is adequate as observed and it is recorded here mainly to confirm that the security and access-control basics are already in place, which is a reasonable starting point for the more specific improvements recommended elsewhere in this report.

Plate 2.1: Perimeter Wall Showing Fire Point and Muster Point Signage

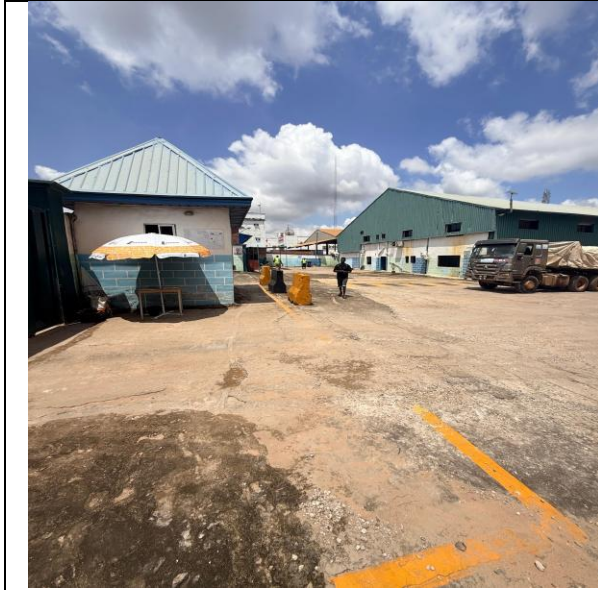
The truck yard occupies most of the depot's open compound space and is fully paved, with yellow demarcation lines marking out parking, loading and pedestrian areas, and yellow-painted wheel stoppers or kerb blocks positioned in front of the office block. Trucks observed on site during the visit included an articulated haulage vehicle with tarpaulin-covered cargo and a smaller rigid truck, both parked within the marked yard rather than obstructing the expressway. The general standard of demarcation and housekeeping in the yard is reasonable; the specific concern in this part of the compound is the drainage fall toward the low corner described in section 3.3, which needs a catchment pit sited clear of the truck movement and turning paths.

Plate 2.2: General View of the Depot Yard, Office Block and Truck Bay

The standing water at the inner part of the compound, shown in Plate 3.4, needs a properly built catchment pit rather than continued reliance on the ground's own, evidently poor, infiltration. Before the pit is sized, a simple percolation test at the proposed location is recommended, since the compound is fully paved and the infiltration capacity of the underlying ground is unknown; this will determine how large the pit needs to be, and whether it can be a simple soakaway or needs to be lined and pumped. The pit should be sited clear of the truck loading and manoeuvring paths described in section 2.5.2, and set back a reasonable distance from the borehole, generally accepted

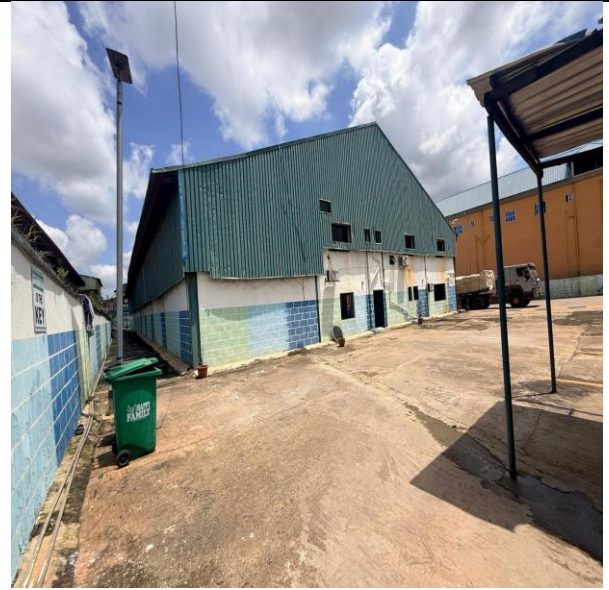
Plate 2.3: Covered Waste Bin at the Depot Frontage

A covered, wheeled waste bin is positioned within the compound for general refuse. It appeared to be in reasonable condition and properly covered at the time of the visit. What was not confirmed is who collects it, how often, and whether that collector is licensed as required under the Anambra

The covered waste bin observed at the depot (section 2.5.7) is adequate as it stands; what needs confirming is who empties it. The collector should be checked to confirm registration with the Anambra State Waste Management Authority, and waste should continue to go only to a designated disposal site, in line with Sections 135 to 137 of the Anambra State Environmental Management, Protection and Administration Law, 2024, which between them require a covered bin, prohibit open burning, and require waste to be taken only to an approved site. Should the depot ever generate oil, grease or similar liquid waste, from vehicle servicing carried out on site, for instance, this should be stored separately and disposed of through a properly licensed route rather than into the yard drains, in line with Section 141 of the same law.

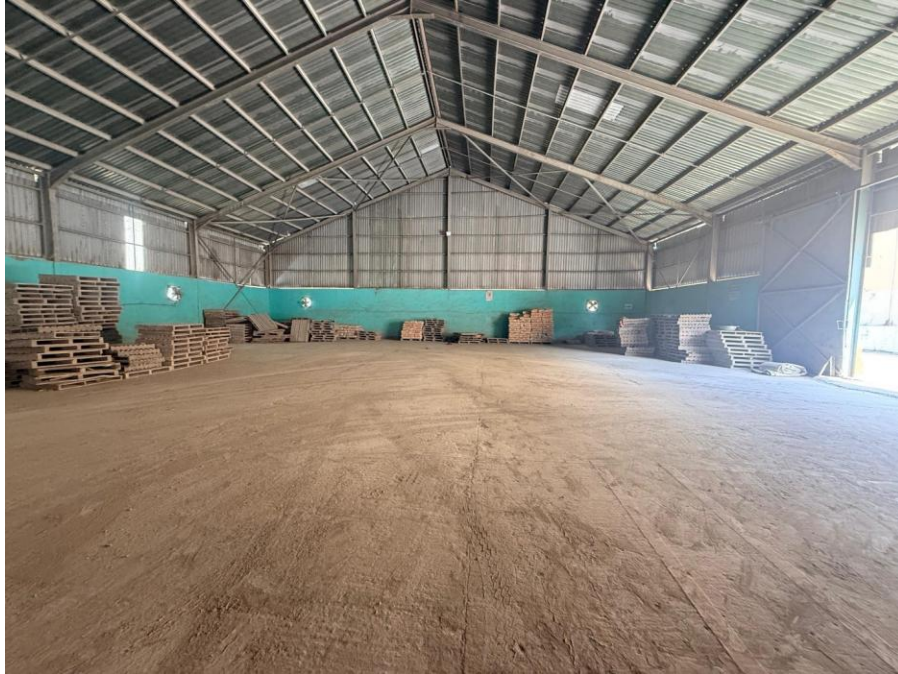
The main storage building is a steel-framed structure with a high pitched roof and corrugated metal cladding, painted in the depot's house colours on the lower courses. Internally, bagged product is stored on wooden pallets stacked against the side walls, leaving a clear working floor down the centre for forklift or hand-truck movement. Wall-mounted extractor fans are fitted along both long walls to help with ventilation, and the floor, while structurally sound, carries a visible film of fine dust consistent with the ordinary handling of bagged material rather than any particular fault in the building. No mechanical dust extraction was observed at the point where bags are opened, stacked, or loaded, which is worth noting for the dust-control measures to be developed in Chapter Four.

Plate 2.4: Interior of the Storage Warehouse with Palletised Stock

The air quality readings in section 3.4 were reassuring as far as they went, but they were taken without active loading, and dust from bag handling and truck movement is the depot's most obvious air quality concern precisely because it was not captured on the day of the visit. The practical measures recommended are unglamorous but effective: damping down the yard's dusty surfaces during the dry season and especially through the harmattan months described in section 3.2, sweeping up spilled product promptly rather than letting it accumulate and get kicked up by traffic, and issuing dust masks to workers directly handling bags at the loading point. The warehouse's existing wall-mounted extractor fans (section 2.5.3) should be checked to confirm they are still working and are adequate for the space; if the repeat monitoring recommended below shows a real problem at the warehouse door, additional local extraction at the specific point where bags are opened and stacked would be the next step, rather than a general assumption that more fans are needed everywhere.

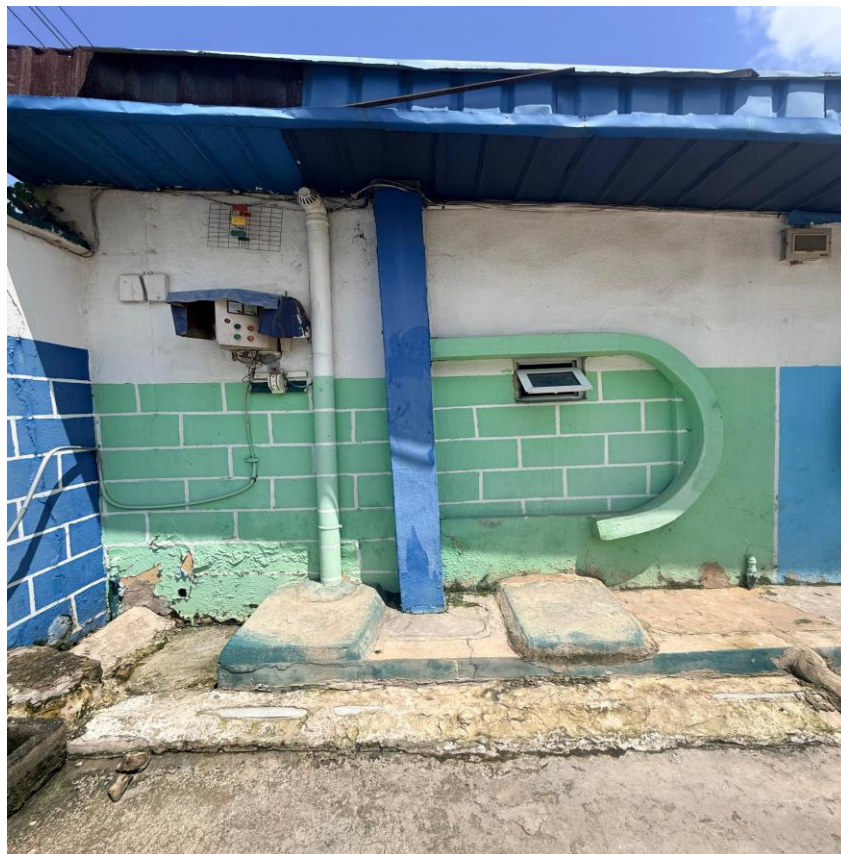
This is the single infrastructure item most clearly flagged during the site visit as needing attention. The rest house provided for drivers and loaders is small relative to the numbers who use it at any one time, and its attached convenience has a window too small to ventilate the space properly. The photograph below shows the external wall of this facility, including the narrow, louvre-style window in question. On a warm afternoon, and with the door likely to be kept shut for privacy, a space this poorly ventilated is uncomfortable to use and, over time, is the kind of condition that pushes people toward avoiding the facility altogether, which is its own hygiene problem. This is treated in Chapter Four as a priority corrective item, subject to the landlord consultation described in section 2.2.

Plate 2.5: Drivers/loaders Facility Showing the Undersized Convenience Window

The rest house and its attached convenience, described in section 2.5.6, is the single item this EMP treats as needing attention without further delay. The recommended fix is straightforward in principle even if it takes some working out in practice: the facility needs to be sized to the number of drivers and loaders actually using it on a typical day, once that number is confirmed (section 3.9.3), and the convenience needs a window large enough, or an extractor fan fitted, to move air through the space properly. Whether this is best done by extending the existing structure, reconfiguring the space already available, or fitting a mechanical extractor to the current small window as an interim measure, is a decision for the proponent and its facilities team to make once the landlord consent position in section 4.9 is settled. What matters for this EMP is that the fix, whichever form it takes, restores the facility to a standard the depot's own workers would actually want to use, since a facility people avoid using is not really solving the hygiene problem it exists to solve.

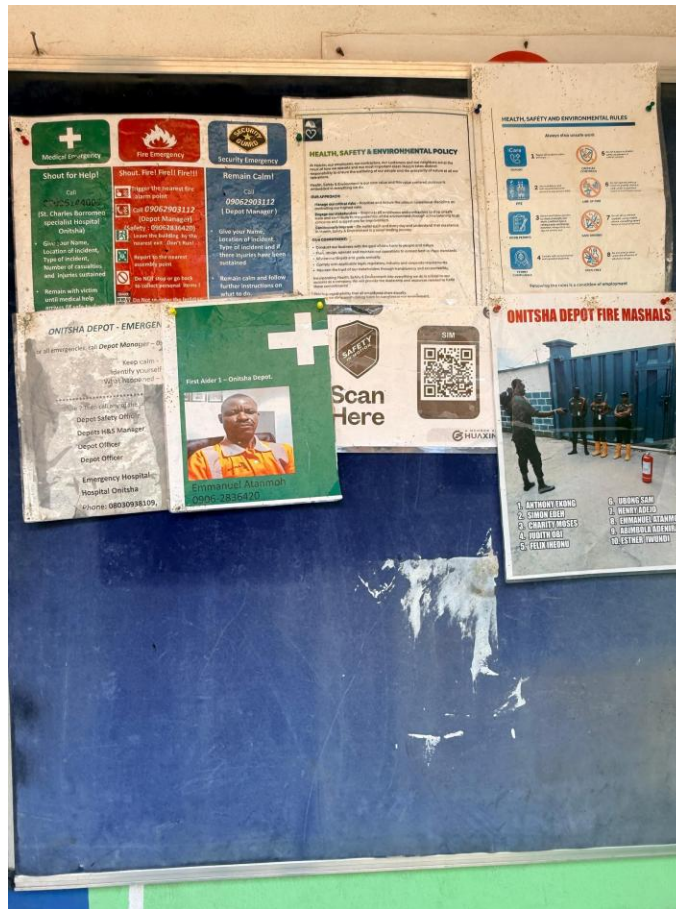
The depot maintains a more developed occupational health and safety programme than a facility of this size is typically expected to have. A dedicated noticeboard, reproduced in Plate 3.1 below, displays a Health, Safety and Environmental Policy setting out four commitments (managing risk, engaging stakeholders and contractors, continuous improvement, and maintaining stakeholder trust), together with a set of site rules covering the authority to stop unsafe work, personal protective equipment, control of critical risks, staying out of the line of fire, a work-permit system, safe driving, a drugs-free workplace, and general operational compliance. Table 3.3 summarises what this noticeboard, and the wider site visit, found in place.

**Plate 3.1: Health, Safety and Environmental Noticeboard at the Depot**

The depot's existing occupational health and safety programme, summarised in Table 3.3, is a genuine strength and the right foundation to build on rather than replace. The recommendations here are extensions rather than a fresh start: issuing dust masks and, if the noise study in section 4.5 confirms the need, hearing protection, to workers whose duties put them regularly in the yard; keeping the fire marshal roster and first aider list current as staff change; continuing the monthly toolbox talk habit that a site with this level of documented policy almost certainly already has, and using it to cover the specific findings of this report as they are addressed; and continuing to use the existing "Safety in Motion" digital reporting channel to log near misses and hazards related to dust, noise, and the facility issues raised in this chapter, so that the group-level system already in place captures depot-specific data rather than only broad categories.

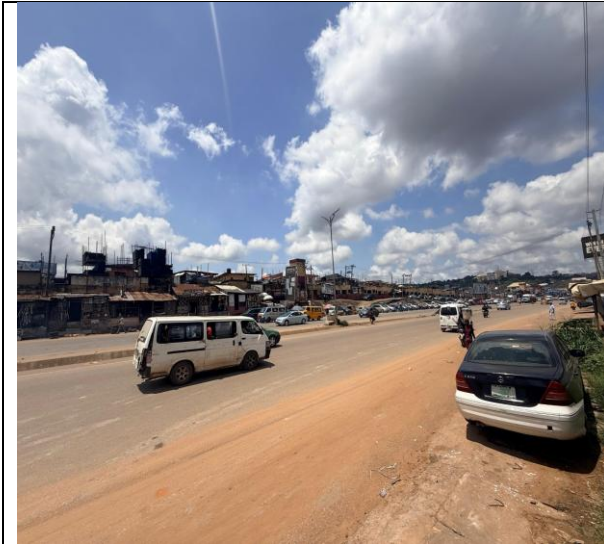
Plate A.1: Traffic Conditions on the Onitsha-Enugu Expressway Near the Depot Frontage

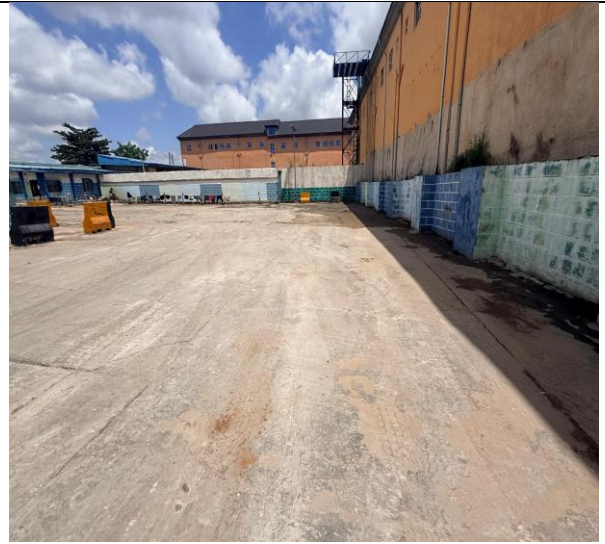
Plate A.2: Yard Corner Showing Painted Parking Blocks

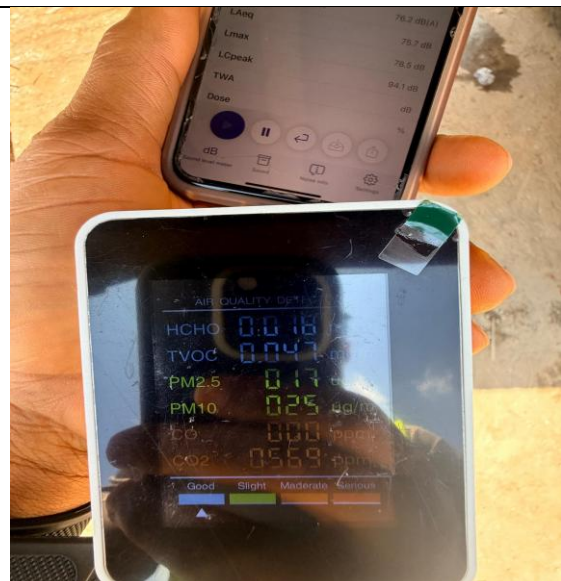
Plate A.4: Sound Level Meter Reading Taken on Site

The three noise readings in section 3.5, ranging from 57.5 dB(A) LAeq at the inner end of the compound to 68.9 dB(A) at the gated entrance, show a clear gradient across the site and are treated in this EMP as a genuine finding rather than a one-off anomaly to be explained away. The entrance and mid-yard points sit above the lower bound of the indicative daytime range, while the inner end sits below it. Three things are recommended. First, routine good practice: keeping trucks and any yard equipment properly maintained, since a poorly tuned engine or a worn reversing alarm adds
