# ENVIRONMENTAL AUDIT REPORT

## VINEE GAS LIMITED

(LPG STORAGE AND DISTRIBUTION PLANT)  
No. 5 Vinee Oil Crescent, Behind Army Barracks,  
Along Enugu-Onitsha Road, Anambra State, Nigeria

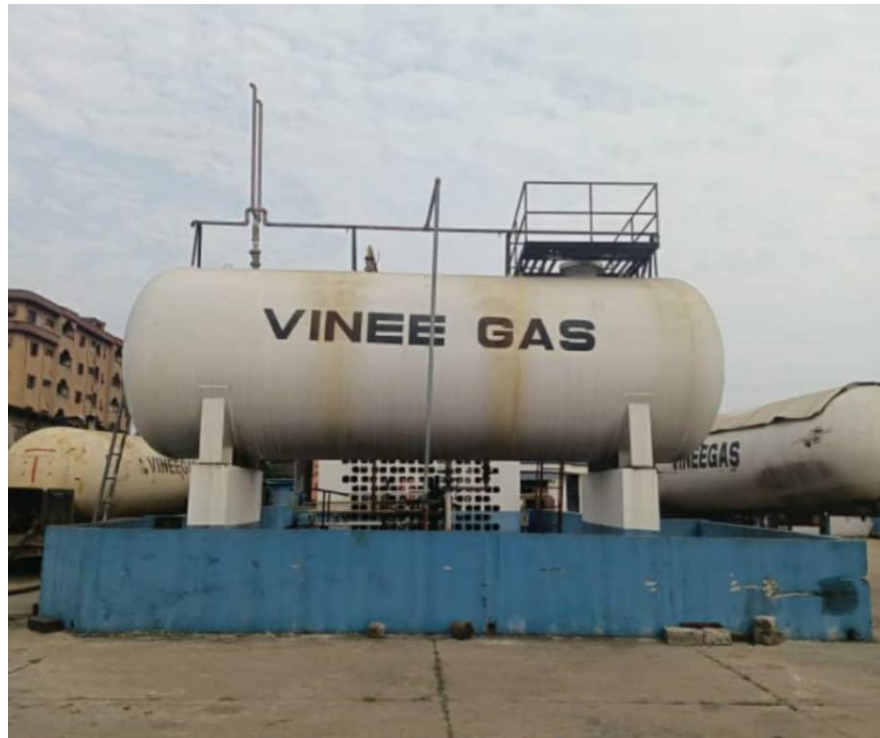
Figure 2.3: Storage tank at the Vinee Gas Plant Facility

Following receipt, LPG is stored in pressurised tanks under controlled conditions. Storage management involves continuous monitoring of tank pressure and temperature to ensure both safety and operational efficiency, inventory reconciliation to account for all product movement, and preventive maintenance schedules to ensure structural integrity of tanks and associated pipework. Pressure relief valves and emergency shutdown systems provide automatic protection against overpressure scenarios.

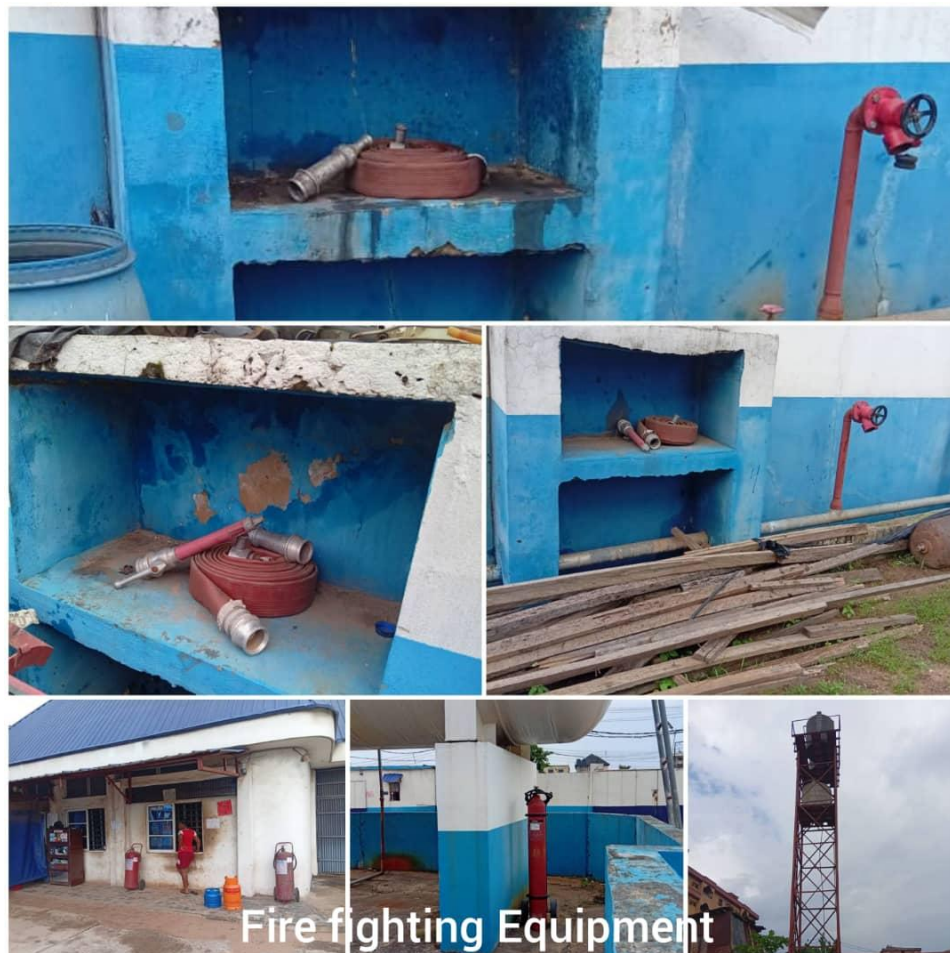
Figure 2.4: Fire fighting equipment

**Safety Equipment:** Fire extinguishers, emergency shutdown provisions, pressure relief valves, and safety signage are present on-site. Emergency exits are identifiable within the operational areas.

Current safety and environmental equipment demonstrates adequate basic coverage for routine operations, while highlighting areas requiring enhancement. Fire suppression equipment includes fire extinguishers positioned at strategic points within the facility. Pressure relief valves are installed on the storage tanks. Emergency shutdown provisions are present in the storage zone. Safety signage (“NO SMOKING” and hazard warnings) is visible in key operational areas.

| Equipment / System | Status | Adequacy | Identified Gaps |
|---|---|---|---|
| Fire Extinguishers | <b>Present</b> | Basic coverage | Enhanced capacity recommended; quantity to be reviewed against NUPRC guidelines |

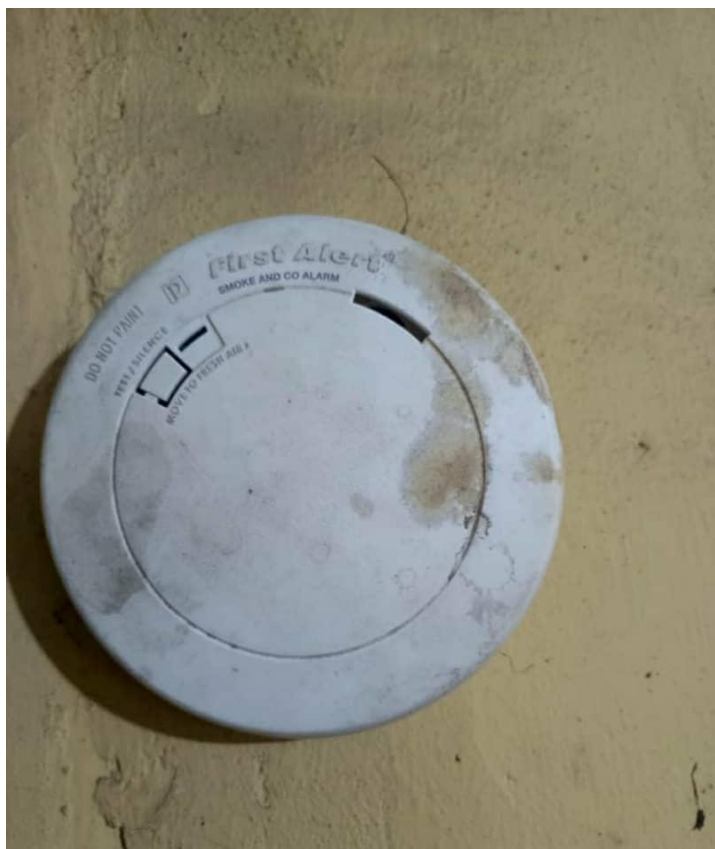
Figure 2.5: Leak detection

| Equipment / System | Status | Adequacy | Identified Gaps |
|---|---|---|---|
| Leak Detection | <b>Visual only</b> | Basic | Automated gas detection system recommended |

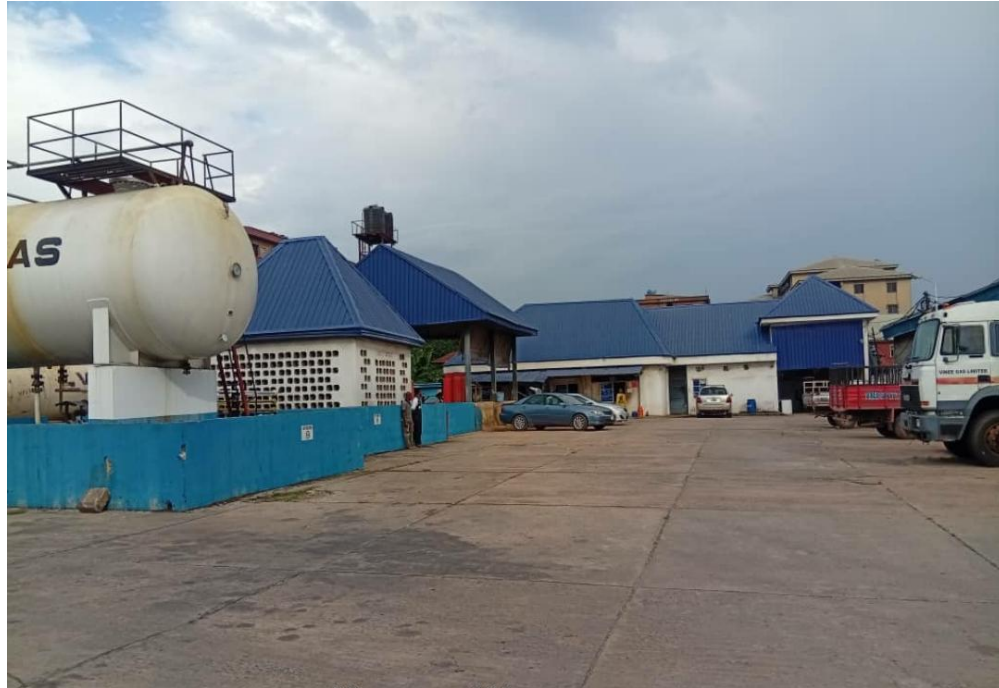
Figure 2. 6: Facility Perimeter view

Based on observations during the audit, the nearest residential structures are located at a buffer distance consistent with NUPRC guidelines for LPG facilities. The study by Okonkwo et al. (2014) on the environmental impact assessment of gas filling stations confirms that volatile organic compounds (VOCs) and methane are the primary pollutants to consider in siting LPG facilities, and that a minimum safe distance of 80 metres from residential areas should be observed. The facility's location provides an appropriate buffer that is generally consistent with this standard.

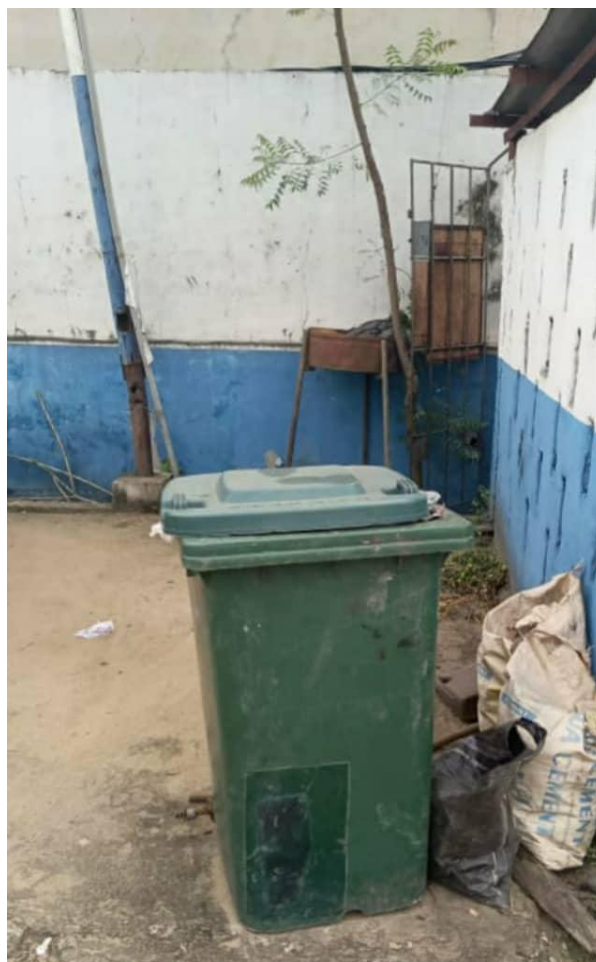
Figure 2.7: Waste storage system

**Waste Management Infrastructure:** Current waste management at the facility relies on on-site bin collection for solid waste. As noted, formal waste management procedures, documentation, and a contract with a licensed waste disposal operator have not yet been established, which represents a compliance gap against S.I.28 of 2009 (Waste Control and Sanitation Regulations) and the Anambra State Environmental Law 2024.
